Report

Serious incidents on **18 March** and **8 April 2010**
at **Paris Charles de Gaulle Airport (95)**
to the **Boeing 747-400s**
registered **HS-TGL** and **B-HOV**
operated respectively by
Thai Airways International Ltd.
and by **Cathay Pacific Airways Ltd.**

BEA

Bureau d'Enquêtes et d'Analyses
pour la sécurité de l'aviation civile

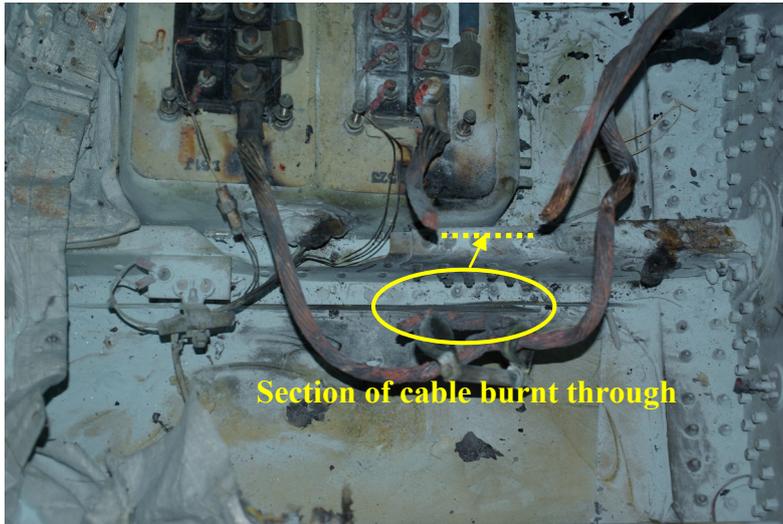
In the avionics compartment, the two cables connecting the neutral to the structure of the aircraft were severely damaged and partially melted. One of them was burnt through in two places by the heat. The insulation blankets were burnt in the area surrounding the electrical connectors. The avionics compartment was filled with dry chemicals from the extinguisher.

Avionics compartment electrical

In this area, the structure of the aircraft's fuselage was subjected to significant heating (800 °C) that required major repair work before the aircraft could be returned to service.

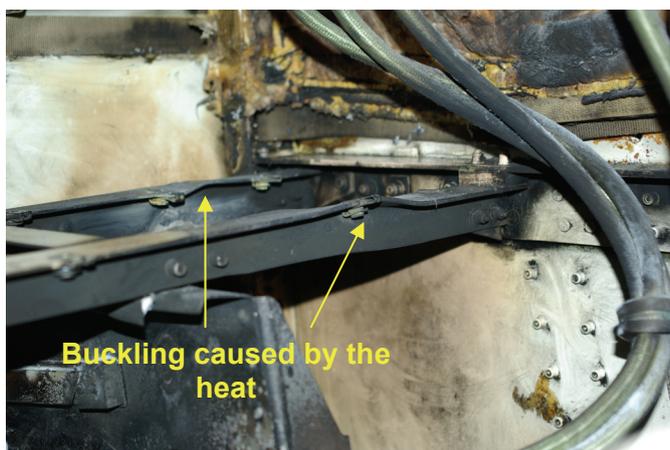
In the avionics compartment, the cables linking the neutral to the aircraft structure were partially melted, but not burnt through. The insulation blankets were burnt in the area surrounding the electrical connectors. In the avionics compartment, a little of the dry chemicals from the extinguisher was present around the connectors though in smaller quantity than in the case of the event involving HS-TGL. The outer connectors showed signs of heating, and bore traces of dry chemicals from the extinguisher.

The overheating caused by the fire led to a deformation of the aircraft fuselage structure. Major repair work also had to be undertaken before the aircraft could be returned to service.

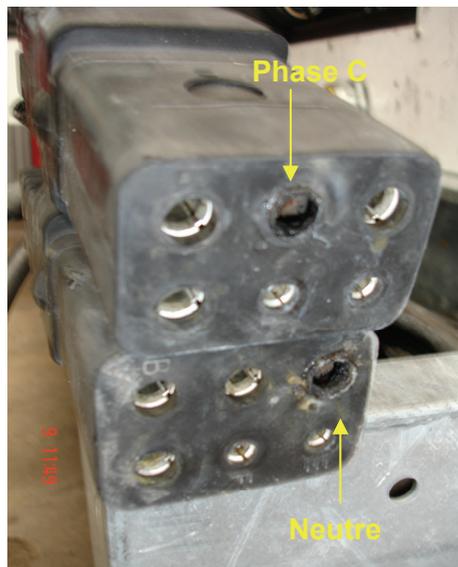
After the incident, the GPU was immediately taken out of service. The electrical cables between the GPU and the aircraft showed significant signs of heating that led to a reduction in their cross section. The elastomer boxes that surround the contacts also showed signs of heating on the neutral on one plug and on the phase C on the other.

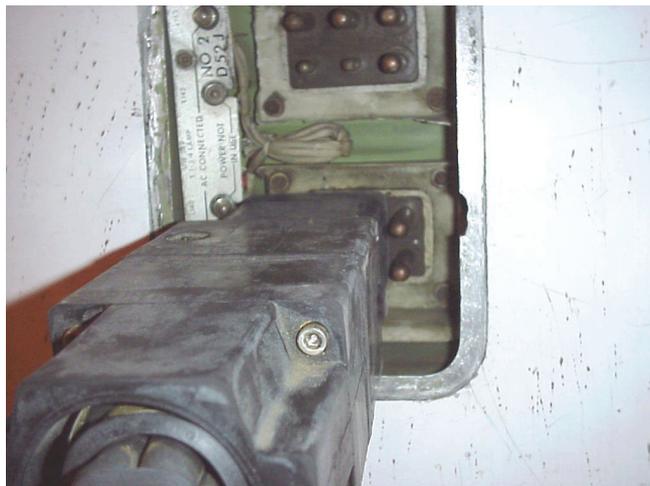
Observation of the damage showed that in all of these cases the phase C had been connected directly to the neutral.

An internal Boeing study, undertaken in 2002, showed that the composite material guide, which ensured positioning of the ground power receptacles, could be damaged. In this situation, it is possible to align the plugs incorrectly. At the time, Boeing had not identified the problem as having any effect on safety.

Example of incorrect connection (Boeing source)

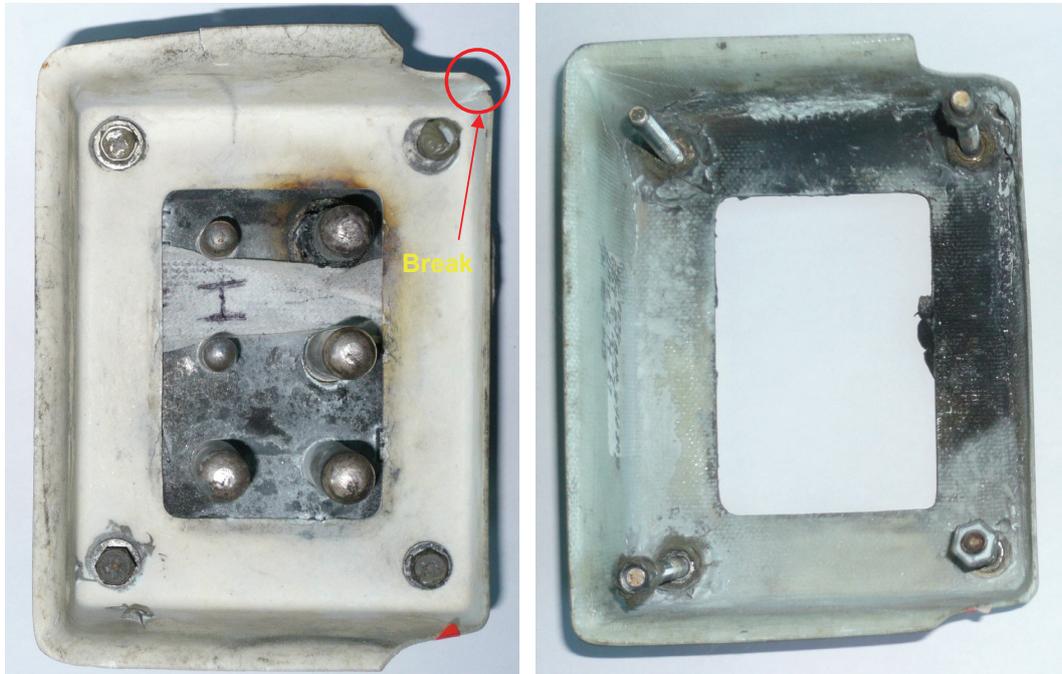
Following the serious incidents to HS-TGL and B-HOV, some tests were performed in cooperation with Cathay Pacific Airways and one of the GPU maintenance companies. The original guides from B-HOV were removed. One of them was broken.

Guides from B-HOV

- ❑ Ground technicians using the GPU receive limited training and have limited technical knowledge of the aeroplane's electrical system.
- ❑ On B-HOV, the guide made of composite materials on connector No1 was broken.

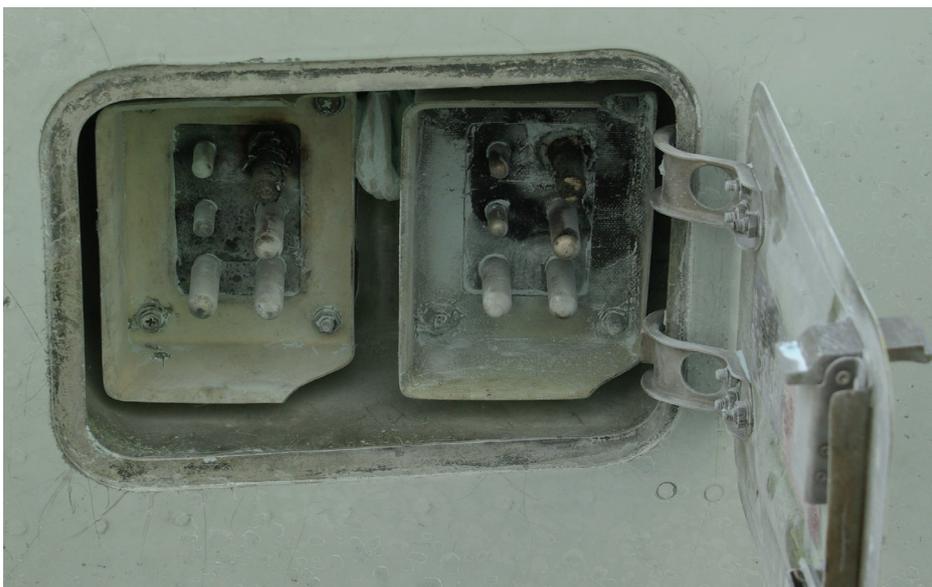
Observation of the burn marks on the external connectors on B-HOV indicate that the electrical connector plugged into connector No2 (on the right in the photo below) was incorrectly positioned. The connector guide was not broken. It was not possible to determine which electrical connector was incorrectly positioned on the HS-TGL.

Electrical connectors from B-HOV a short time after the incident

- ❑ On B-HOV one of the electrical connectors was correctly lined up on connector No1 while the second was misaligned on connector No2. On circuit No2 the phase C supplied by the GPU was directly linked to the aeroplane's neutral.

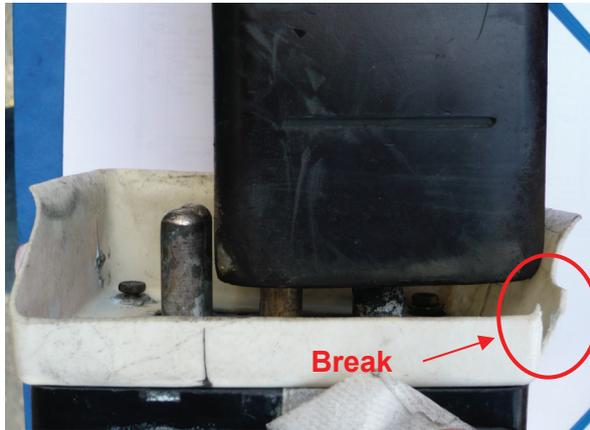
With the original guide, broken, incorrect connection is easy. Engagement was incomplete but contact was established:

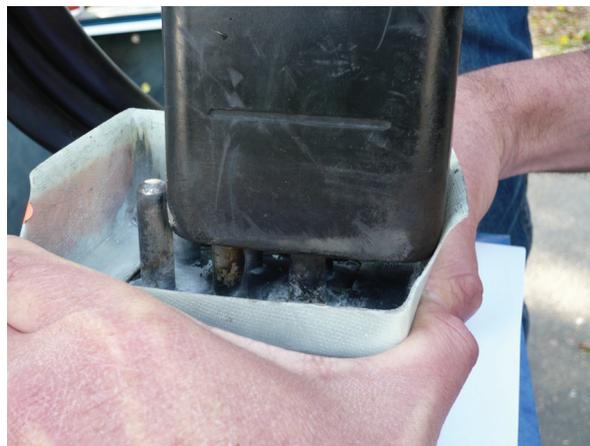
With the original guide, unbroken, incorrect connection was also possible even if it needed slight force. Engagement was not complete but contact was established.

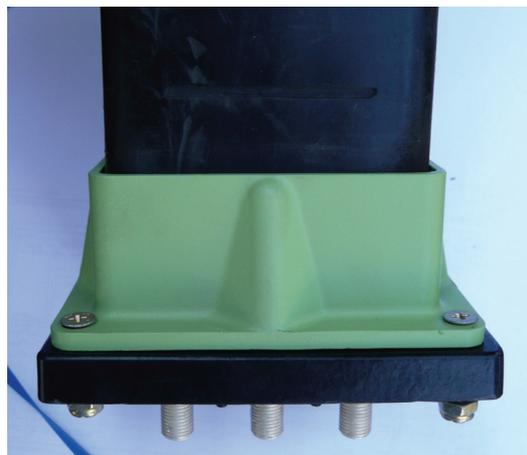
With the MS17845-1 metal guide, incorrect alignment of the electrical connector was impossible:

- **EASA and the FAA make mandatory the replacement of the original parts, with the reference 66-9236, by parts with the reference MS17845-1 on all versions of B747 aeroplanes.**
